**Flood Control Project Maintenance
Levee Inspections**
LMA District Cover Sheet
Spring 2014 Levee Inspection Results

Reclamation District No. 0524 Middle Roberts Island

Spring 2014 Levee Inspection Results

| Waterway | | | Bank | Unit Miles |
|--|---|---|---|---|
| Unit No. 01 San Joaquin River | | | Left | 6.26 |

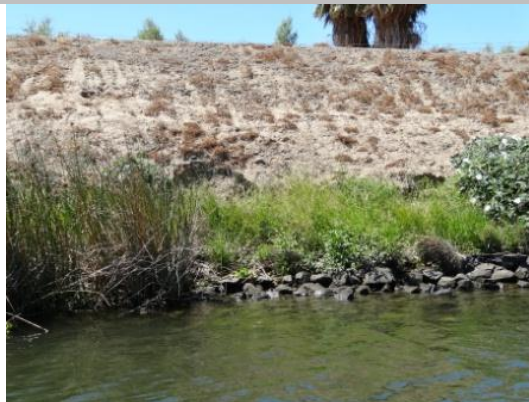
Photo 1 of 1 : richard_s_20140320_101.jpg

| Inspector Comments: 08/13/2013: Erosion was discovered during 2013 spring levee inspection. Inspector comment: Erosion is located along the lower level of water-ward slope. [2013 Site ID:RD0524U01RM40.85] | | | | | |

Front view of erosion.

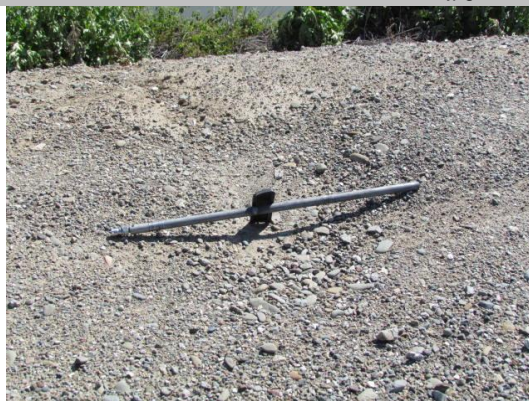
Photo 2 of 3 : richard_s_20140320_108.jpg

Looking east at 3" depression on levee crown. (Spring 2012)

| Repair depressions or ruts in the crown or slope. | | | | | |

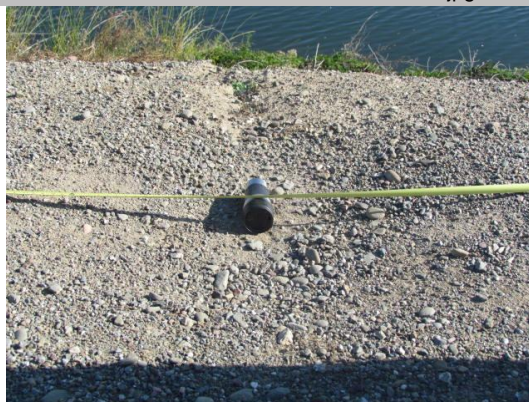
Photo 3 of 3 : richard_s_20140320_109.jpg

Looking west at depression on levee crown near waterward shoulder.

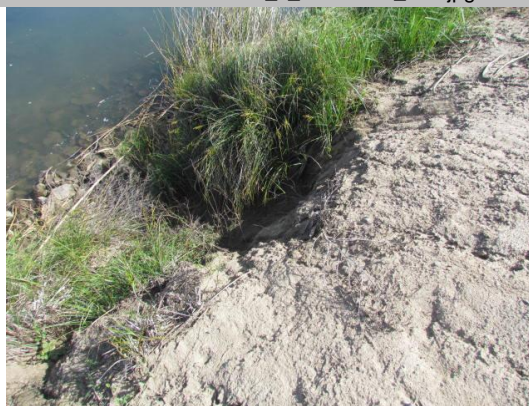
Photo 2 of 2 : richard_s_20140411_519.jpg

Looking southeast at erosion on waterward toe.

| Schedule repair of erosion site prior to the next inspection. Inspector Comments: Erosion is located along the lower level of waterward slope. | | | | | |

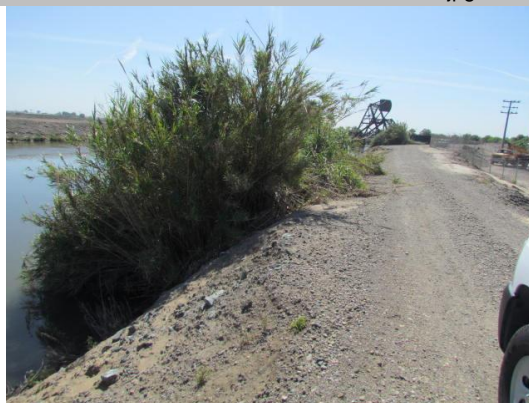
Photo 1 of 3 : richard_s_20140320_114.jpg

| Inspector Comments: Bamboo on waterward slope. | | | | | |

Looking southeast at bamboo on waterside slope. (Spring 2012)

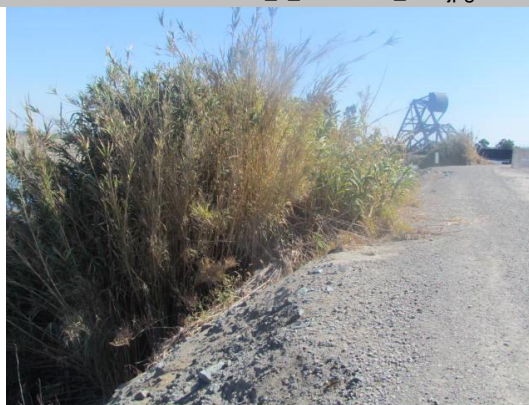
Photo 2 of 3 : richard_s_20140320_115.jpg

Looking south at bamboo on waterside slope. (Fall Inspection 2012)

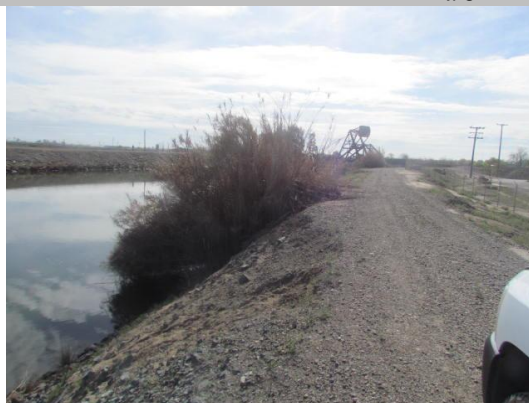
Photo 3 of 3 : richard_s_20140320_116.jpg

Looking south at dying bamboo on waterward slope. (Spring 2013)

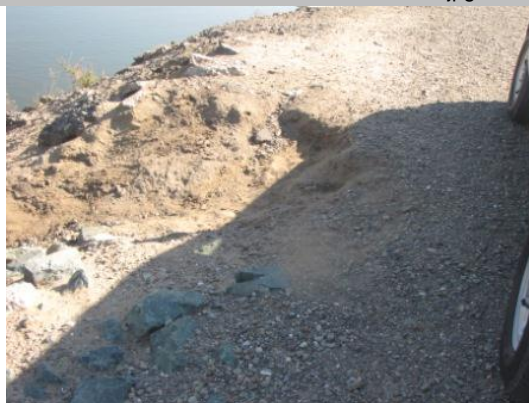
Photo 2 of 3 : richard_s_20140320_119.jpg

Update of erosion site at LM 0.65 to 0.66

| Repair slope instability. | | | | | |

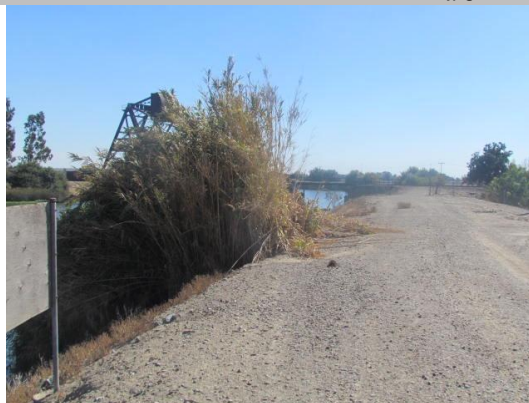
Photo 2 of 3 : richard_s_20140320_122.jpg

Looking south at bamboo on waterside slope. (Fall 2012)

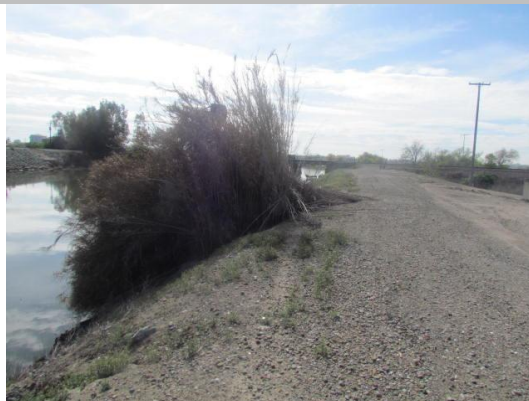
Photo 3 of 3 : richard_s_20140320_123.jpg

Looking south at dying bamboo on waterward slope. (Spring 2013)

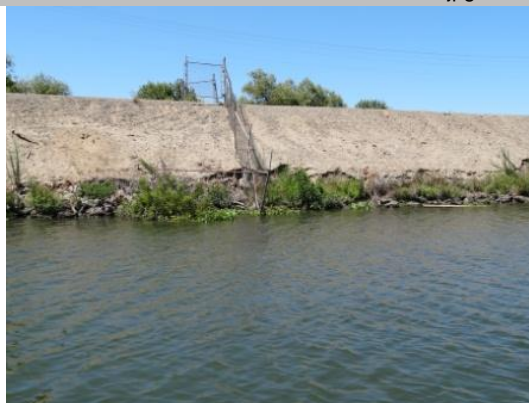
Photo 1 of 1 : richard_s_20140320_168.jpg

| Inspector Comments: 08/13/2013: No significant change at this site. | | | | | |

Upstream view of the erosion site.

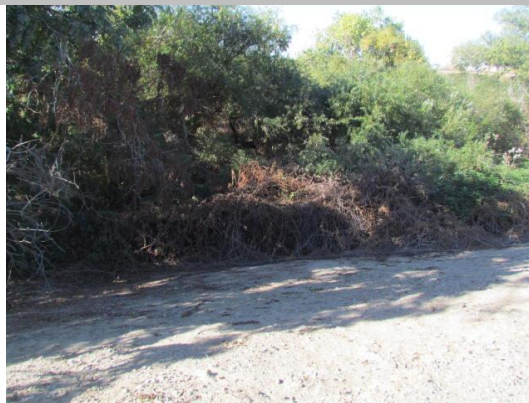
Photo 1 of 2 : richard_s_20140320_237.jpg

| Inspector Comments: Dense vegetation at landside toe along fence line. | | | | | |

Looking west at dense vegetation on landside toe.

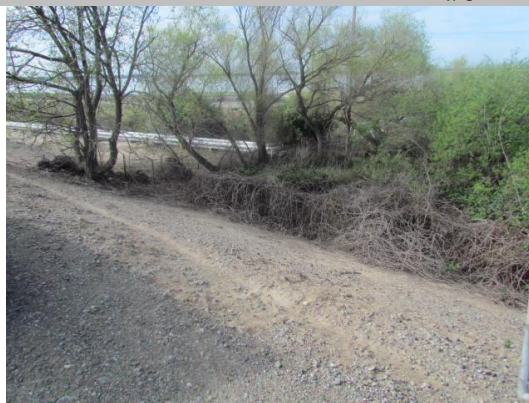
Photo 2 of 2 : richard_s_20140320_238.jpg

Looking southwest at vegetation on landward slope and toe. (Spring 2013)

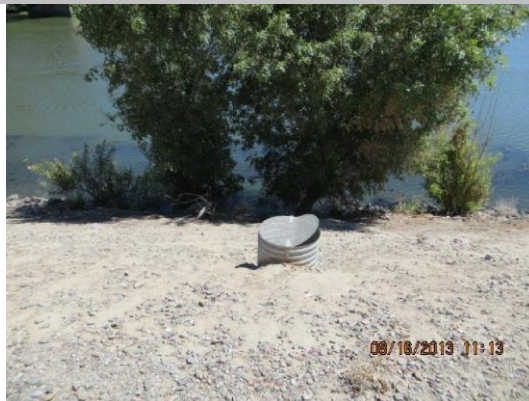
Photo 1 of 1 : UCIP_1620.jpg

Siphon breaker in 24-inch cmp riser on WS slope.

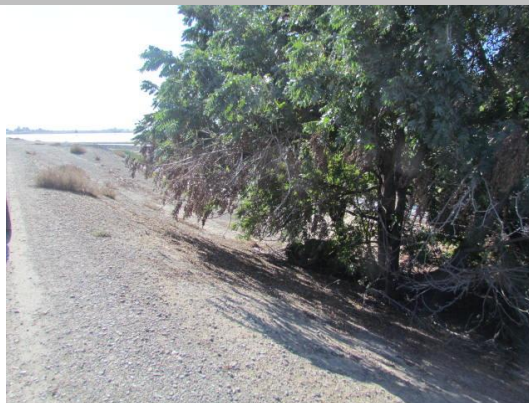
Photo 1 of 1 : richard_s_20140320_178.jpg

Looking southwest at low hanging tree branches at landside toe.

| Trim trees to at least five feet above ground level. | | | | | |

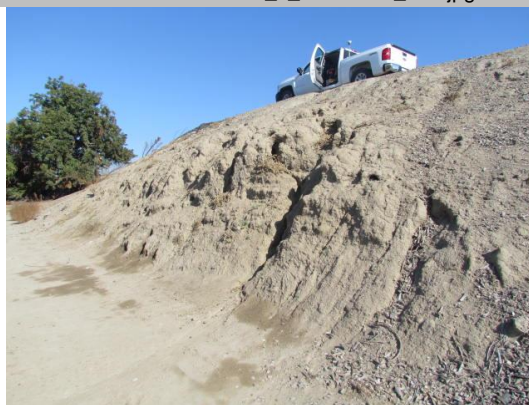
Photo 3 of 5 : richard_s_20140320_104.jpg

| Schedule repair of erosion site prior to the next inspection. Inspector Comments: Several holes and finger erosions on landward slope. | | | | | |

Looking northeast at several finger erosion on landward slope.

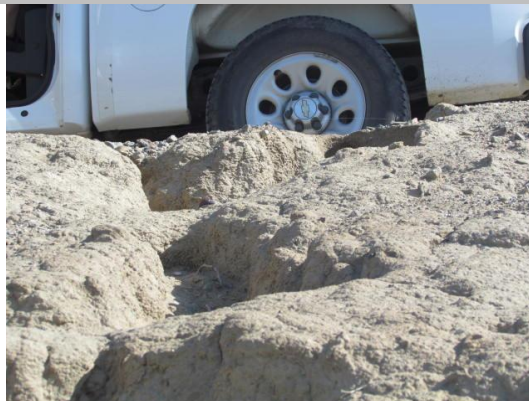
Photo 4 of 5 : richard_s_20140320_105.jpg

Looking east at erosion on landward slope.

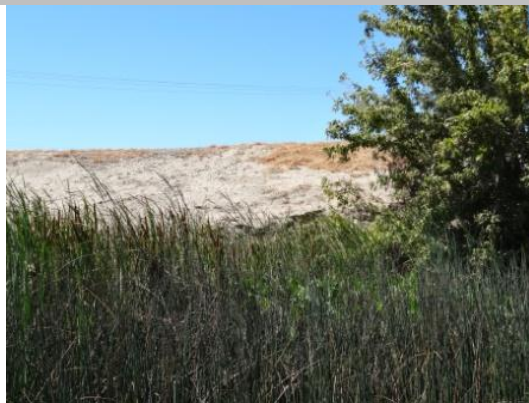
Photo 1 of 1 : richard_s_20140320_181.jpg

| Inspector Comments: 08/13/2013: Site was discovered during boat survey. The dense vegetation blocks a clear view of the erosion. Size of erosion site was very roughly estimated. [2013 Site ID:RD0524U01RM41.44] | | | | | |

Front view of the erosion. The tree and vegetation blocks the view of the site.

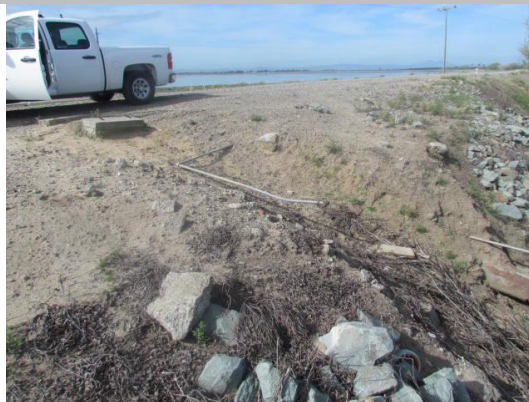
Photo 1 of 1 : richard_s_20140320_215.jpg

| Inspector Comments: Inch and half metal pipe should be removed. | | | | | |

Looking northwest at inch and half metal pipe on waterward slope.

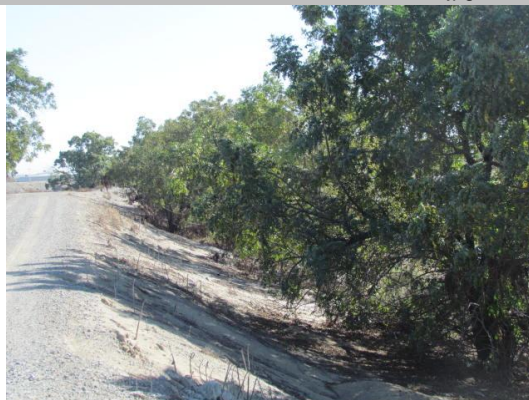
Photo 1 of 1 : richard_s_20140320_179.jpg

Looking south at low hanging tree branches at landside toe.

| Trim trees to at least five feet above ground level. | | | | | |

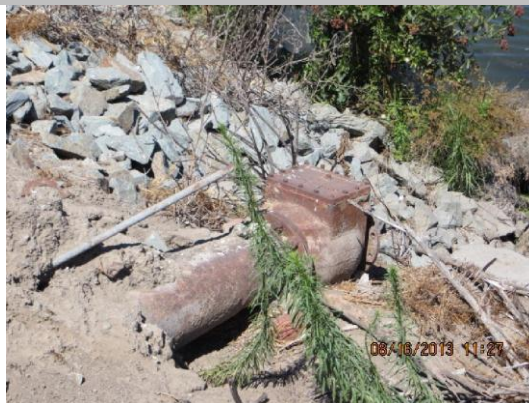
Photo 1 of 1 : UCIP_3045.jpg

Pipe visible on WS slope.

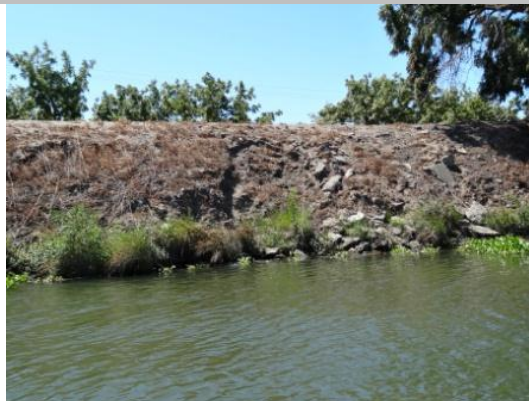
Photo 1 of 1 : richard_s_20140320_217.jpg

| Inspector Comments: 08/13/2013: No significant change at this site. 08/07/2012: The erosion was discovered during the boat survey. [2013 Site ID:RD0524U01RM41.58] | | | | | |

Front view of erosion.

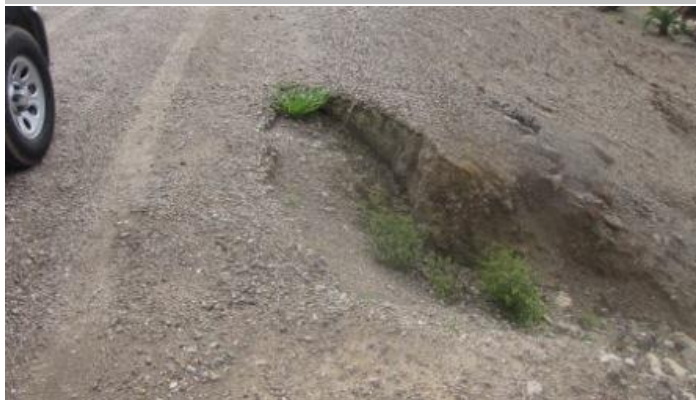
Photo 4 of 5 : richard_s_20140320_131.jpg

Looking at updated slope stability as of 4/2010.

| Repair slope instability. | | | | | |

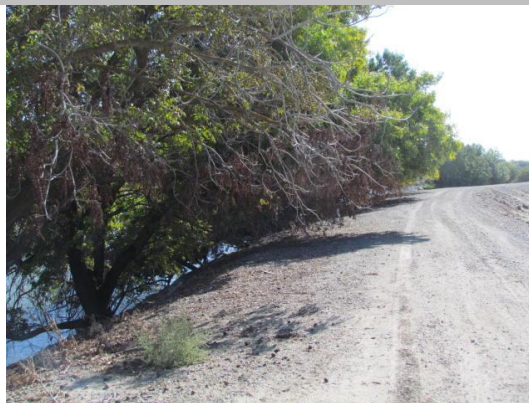
Photo 1 of 1 : richard_s_20140320_133.jpg

Looking northwest at low hanging tree branches at waterside toe.

| Trim trees to at least five feet above ground level. | | | | | |

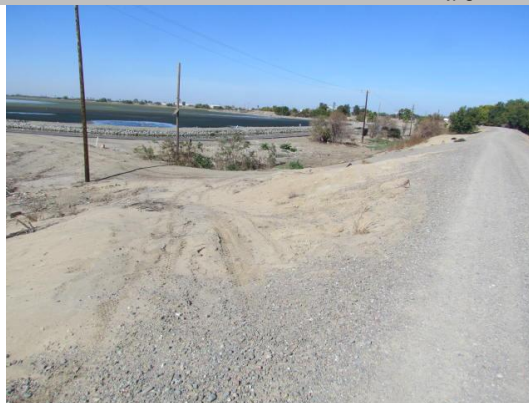
Photo 2 of 2 : richard_s_20140320_240.jpg

| Inspector Comments: Unauthorized ramps on landside slope. Ramps were caused by vehicle traffic. | | | | | |

Looking northwest at unauthorized ramp on landside slope.

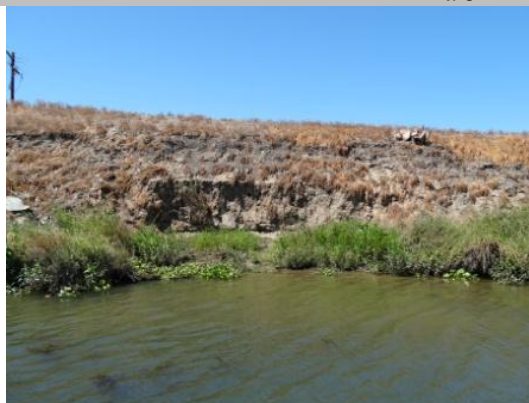
Photo 1 of 1 : richard_s_20140320_219.jpg

| Inspector Comments: 08/13/2013: New signs of animal activity were | | | | | |

Front view of the erosion.

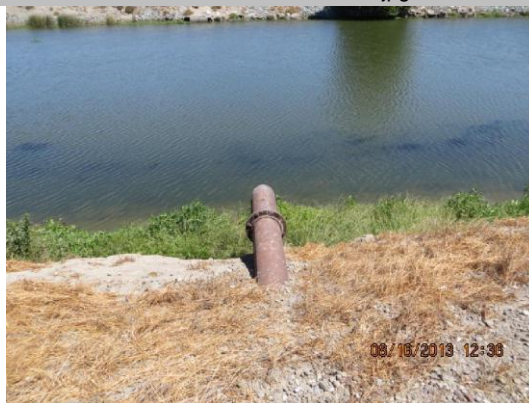
Photo 1 of 1 : UCIP_1626.jpg

Pipe visible and open on WS slope.

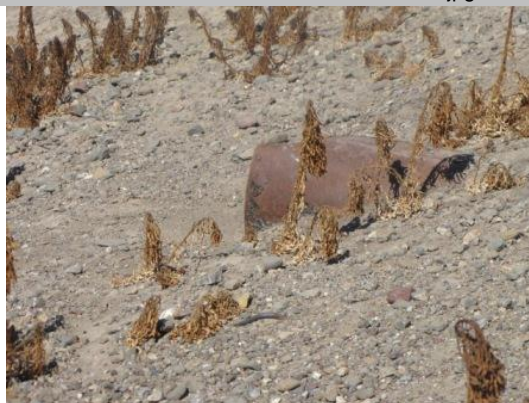
Photo 2 of 2 : richard_s_20140320_144.jpg

| Pipe Inspector Comments: Pipe is not in use and needs to be properly abandoned. | | | | | |

Looking west at pipe on landside slope.

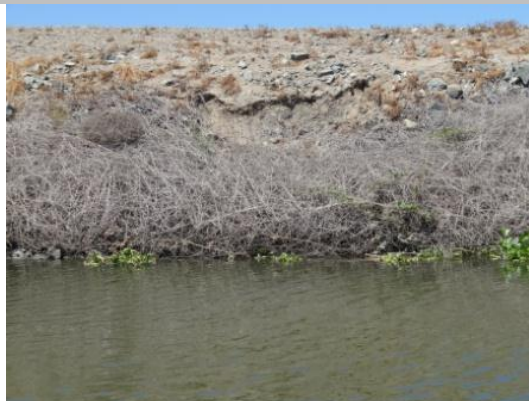
Photo 1 of 1 : richard_s_20140320_221.jpg

| Inspector Comments: 08/13/2013: The site is located approximately 400 ft downstream SR 4 Bridge. Dense vegetation is visible at the toe. [2013 Site ID:RD0524U01RM42.09] | | | | | |

Front view of erosion site.

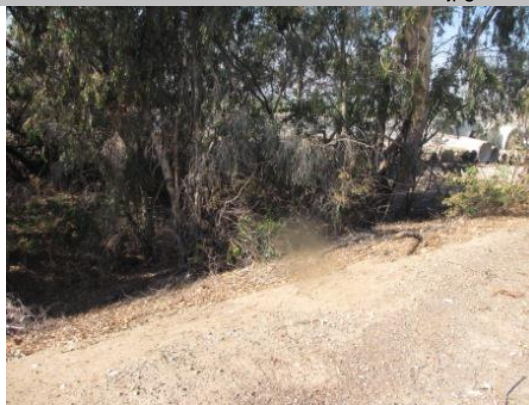
Photo 1 of 3 : richard_s_20140320_247.jpg

Dense vegetation on landside toe.

| Trim and thin trees to allow visibility of the ground and room to flood fight. | | | | | |

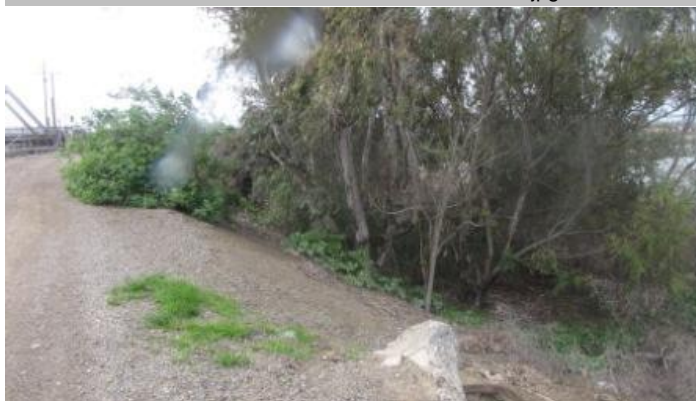
Photo 2 of 3 : richard_s_20140320_248.jpg

Looking south at dense veg. on landside slope and toe.

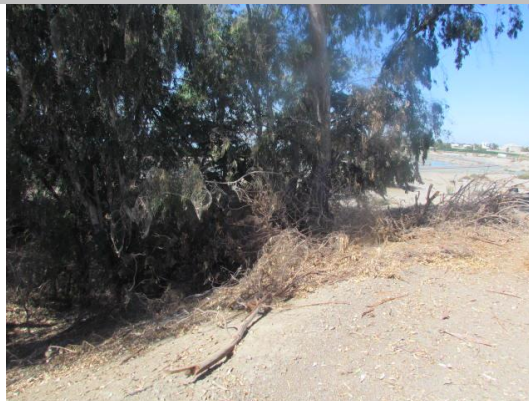
Photo 3 of 3 : richard_s_20140320_249.jpg

Looking south at trees on landside slope. (Fall 2012)

| Trim and thin trees to allow visibility of the ground and room to flood | | | | | | |

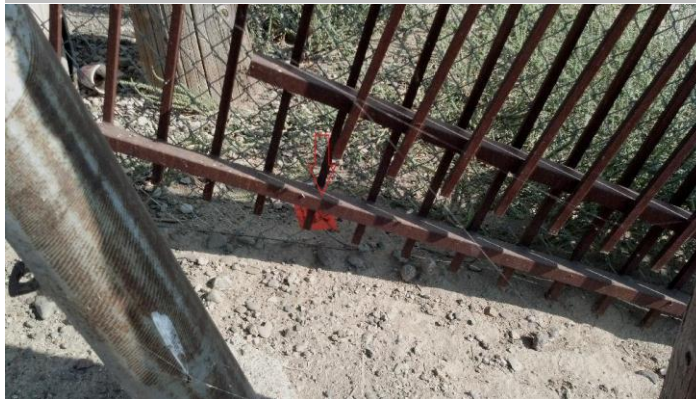
Photo 1 of 1 : UCIP_1628.jpg

USAA markers along alignment at gate.

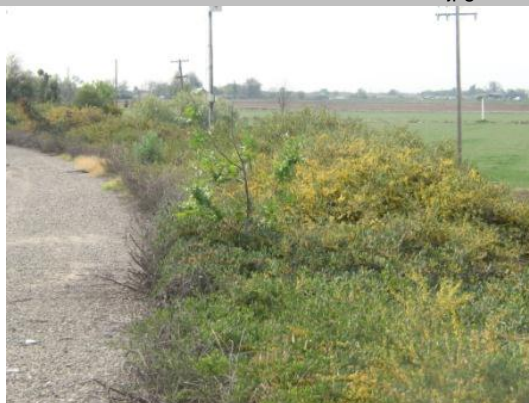
Photo 1 of 1 : richard_s_20140320_136.jpg

Overgrown landscaping on landward slope from LM 1.56 to 1.74

| Remove the wild growth other than native grasses from the levee slopes. | | | | | |

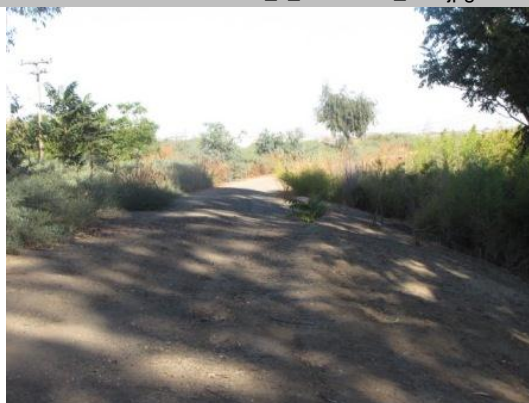
Photo 1 of 1 : richard_s_20140320_137.jpg

Looking north at dense vegetation on the landside and waterside slopes.

| Remove the wild growth other than native grasses from the levee slopes. | | | | | |

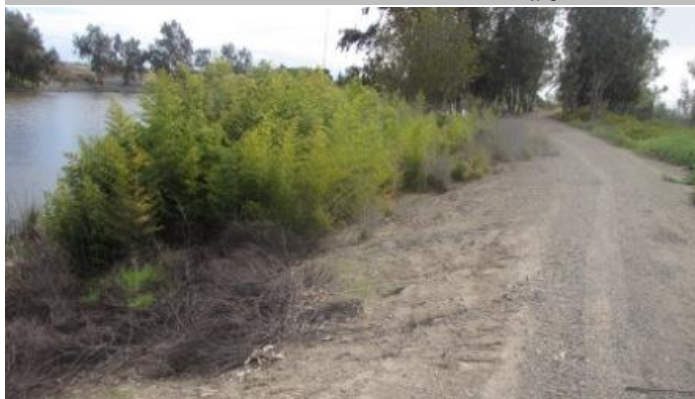
Photo 1 of 1 : richard_s_20140320_138.jpg

Looking southeast at dense vegetation on the waterside slope.

| Remove the wild growth other than native grasses from the levee slopes. | | | | | |

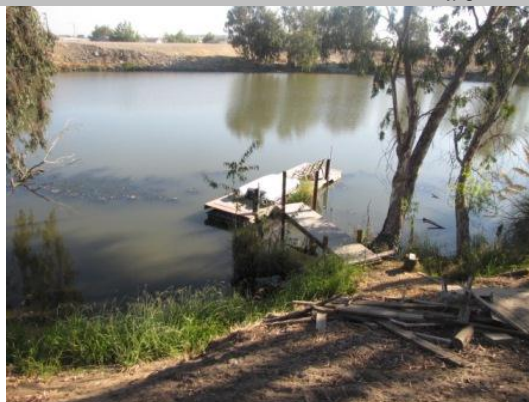
Photo 1 of 2 : richard_s_20140320_154.jpg

| Inspector Comments: Landowner constructed boat dock without permission from the CVFPB. | | | | | |

Looking east at non-permitted boat dock.

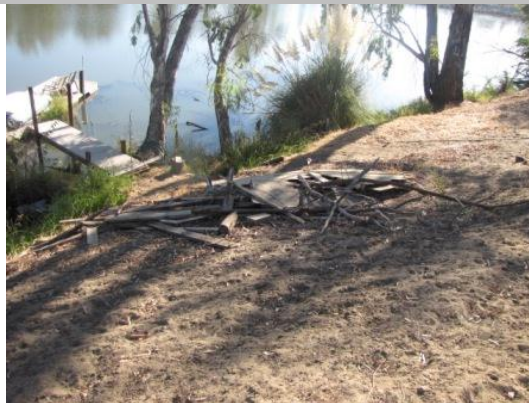
Photo 2 of 2 : richard_s_20140320_155.jpg

Looking at garbage on waterside slope.

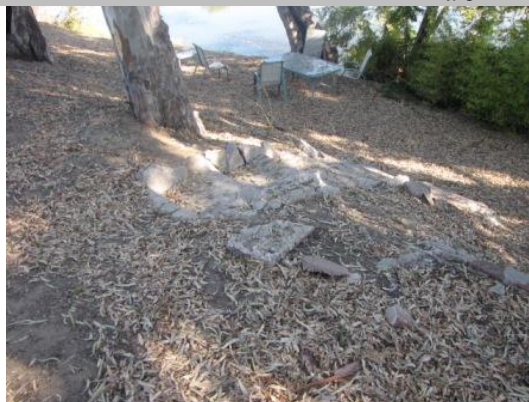
Photo 1 of 3 : richard_s_20140320_159.jpg

| Stairway Inspector Comments: Stairs and retaining wall | | | | | |

Looking northeast on non-permitted concrete stairs on waterside slope.

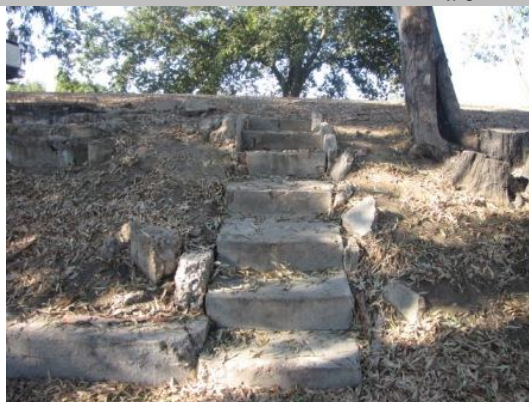
Photo 2 of 3 : richard_s_20140320_160.jpg

Looking west at concrete stairs on waterside slope.

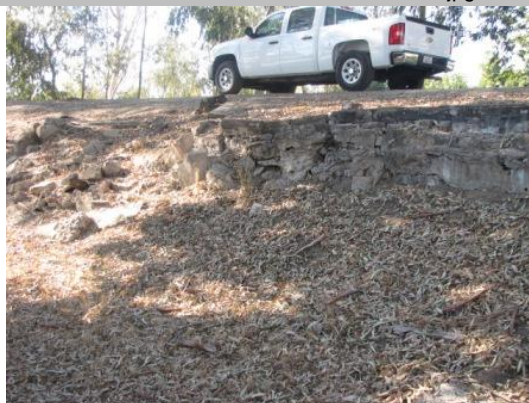
Photo 3 of 3 : richard_s_20140320_161.jpg

Looking southwest at retaining wall connected to concrete stairs.

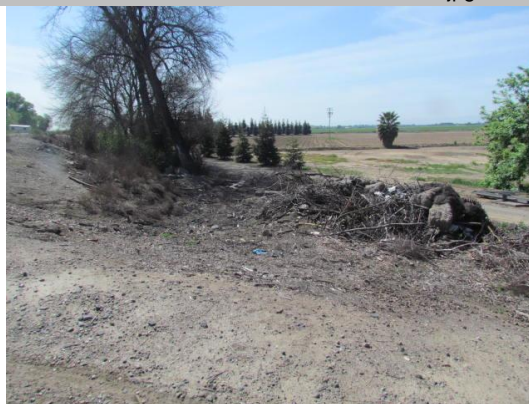
Photo 1 of 1 : richard_s_20140411_520.jpg

| Garbage Inspector Comments: Large pruning piles on landside slope. | | | | | |

Looking at southwest at pruning pile at landward berm.

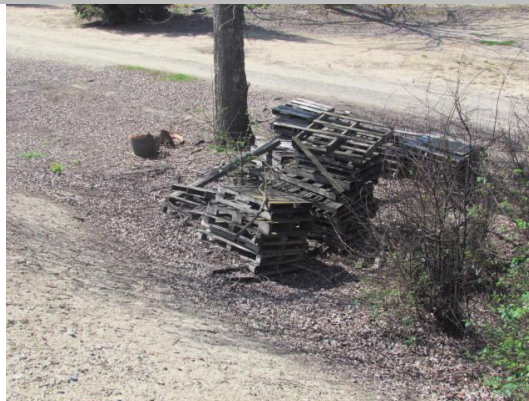
Photo 1 of 1 : richard_s_20140411_521.jpg

| Inspector Comments: Landowner stock piling pallets at landward toe. | | | | | |

Looking west at wooden pallets at landward toe.

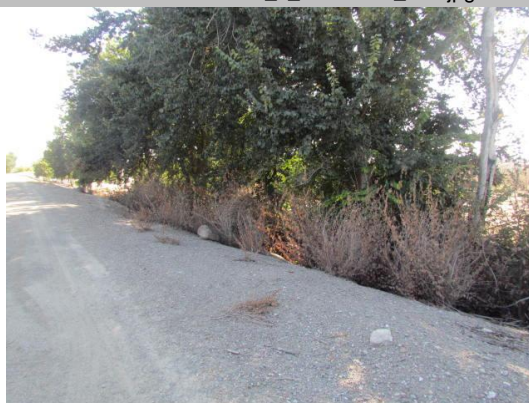
Photo 1 of 1 : richard_s_20140320_162.jpg

Looking southwest at dense vegetation and low hanging tree branches on landside slope and toe.

| Trim and thin trees to allow visibility of the ground and room to flood fight. | | | | | |

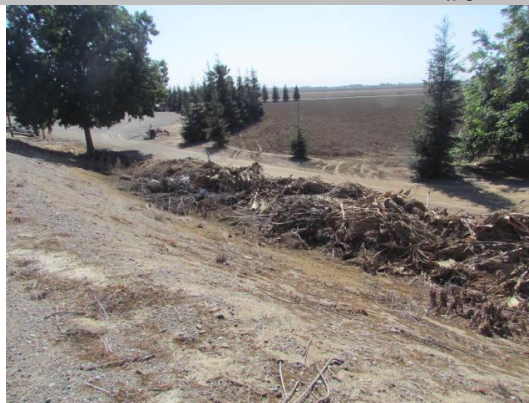
Photo 1 of 1 : richard_s_20140320_195.jpg

Looking southwest at prunings on landside toe.

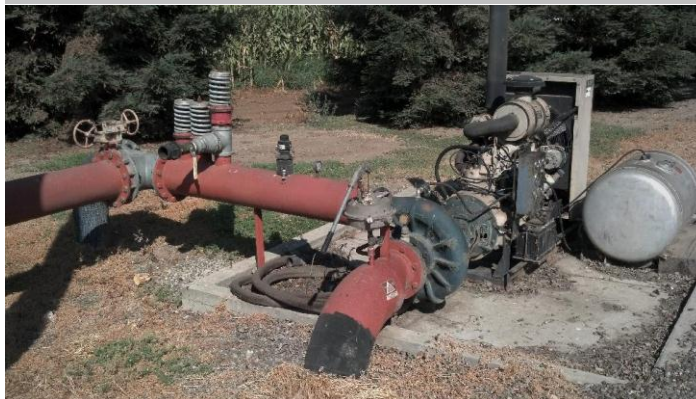
Photo 1 of 1 : UCIP_2774.jpg

Pumping plant with siphon breaker, vents, and butterfly valves.

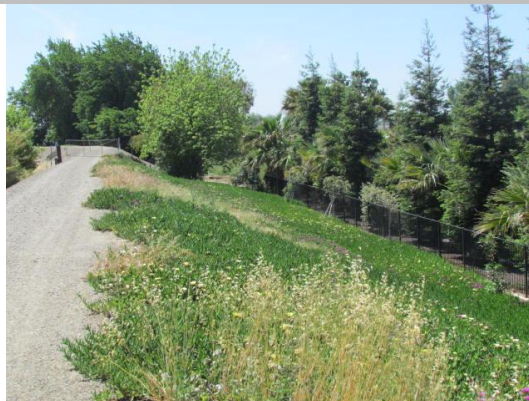
Photo 1 of 1 : richard_s_20140320_180.jpg

Looking southwest at landscaping on landside slope. (Spring 2012)

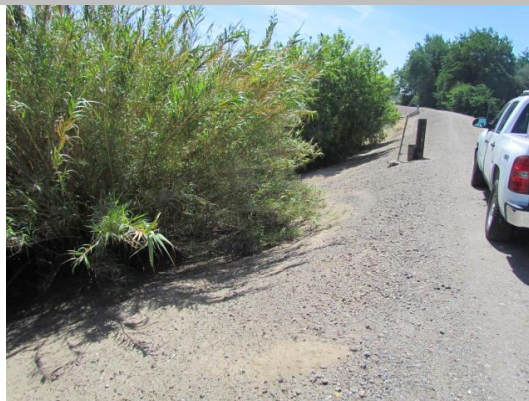
Photo 1 of 2 : richard_s_20140320_199.jpg

Looking southeast at bamboo on waterside slope.

| Remove the wild growth other than native grasses from the levee slopes. Inspector Comments: Bamboo outside of the twenty foot vegetation zone. | | | | | |

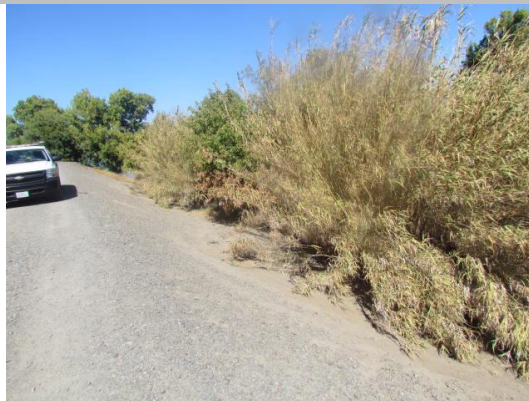
Photo 2 of 2 : richard_s_20140320_200.jpg

Looking northeast at sprayed bamboo on waterside slope. (Fall 2012)

| Remove the wild growth other than native grasses from the levee slopes. Inspector Comments: Bamboo outside of the twenty foot vegetation zone. | | | | | | |

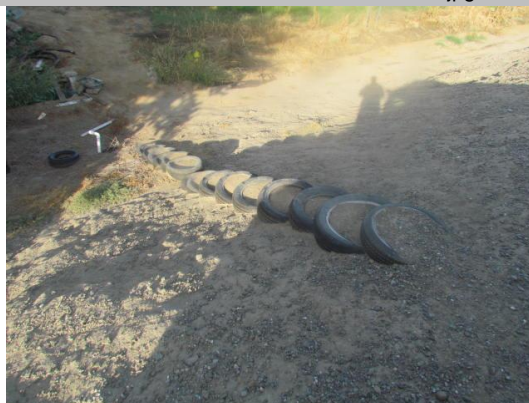
Photo 1 of 1 : richard_s_20140320_110.jpg

| Stairway Inspector Comments: Landowner installed rubber tires for a stairway on landside slope. | | | | | |

Looking west at rubber tires being used as stairs on landside slope.

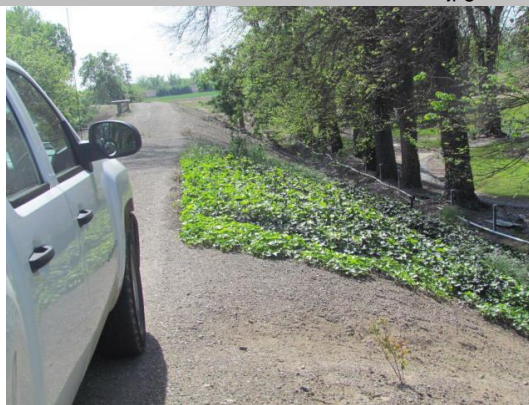
Photo 1 of 1 : richard_s_20140411_522.jpg

Looking southwest at ground cover on landward slope.

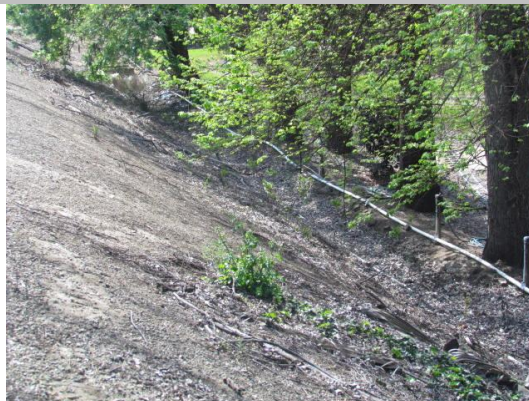
Photo 1 of 2 : richard_s_20140411_523.jpg

| Ditch Inspector Comments: Old irrigation ditch at landward toe should be removed. | | | | | |

Looking southwest at old irrigation ditch at landward toe.

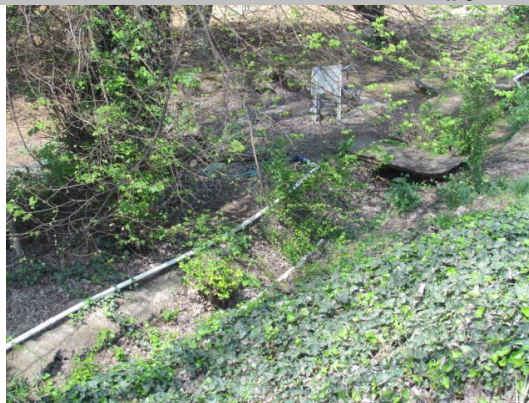
Photo 2 of 2 : richard_s_20140411_524.jpg

Looking northwest at old irrigation ditch at landward toe.

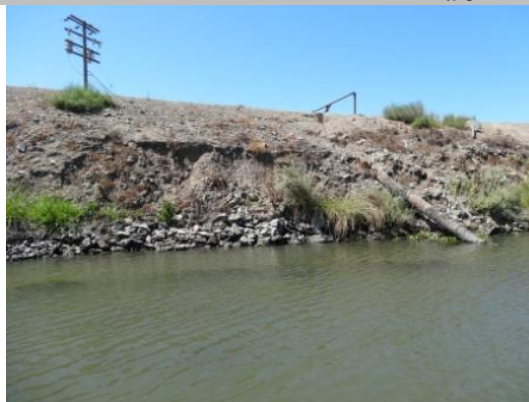
Photo 1 of 1 : richard_s_20140320_224.jpg

| Inspector Comments: 08/13/2013: An irrigation pipe is on site. [2013 Site ID:RD0524U01RM42.84] | | | | | |

Looking from upstream.

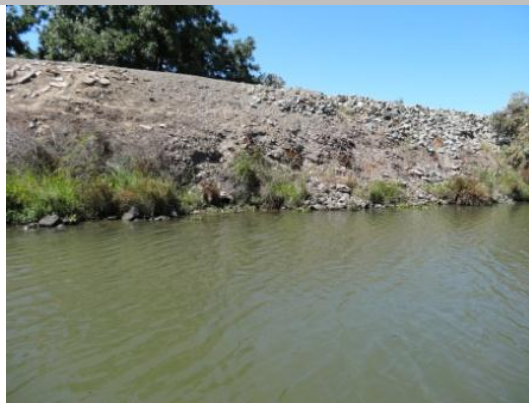
Photo 1 of 1 : richard_s_20140320_225.jpg

| Inspector Comments: 08/13/2013: The length of erosion has progressed downstream, and the site length has increased from 12 ft in length last year to 100 feet in length this year. 08/07/2012: The site was first reported in the 2012 spring levee inspection report. The site is located at the inside corner of a river bend. [2013 Site ID:RD0524U01RM42.93] | | | | | |

Looking from upstream.

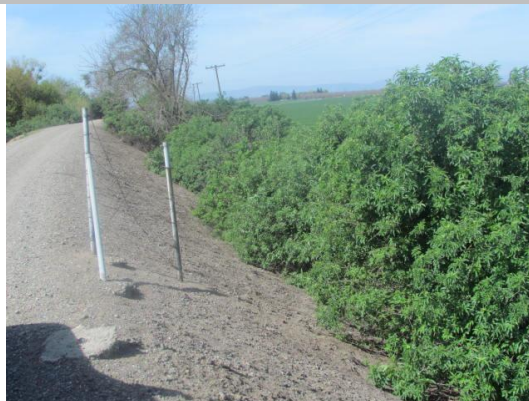
Photo 1 of 1 : richard_s_20140320_146.jpg

| Elderberries are blocking visibility and flood fight capability. | | | | | |

Looking southwest at dense vegetation on landward toe.

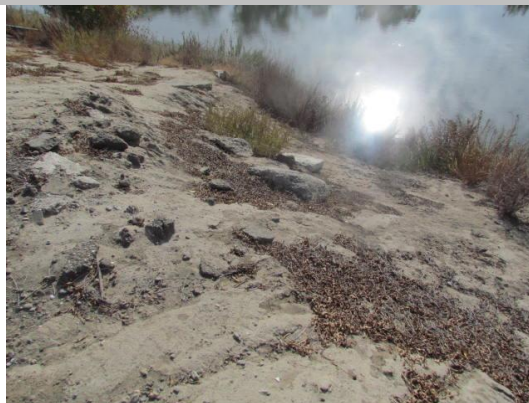
Photo 1 of 1 : richard_s_20140320_147.jpg

Looking east at erosion on waterside slope.

| Note and monitor erosion site. | | | | | |

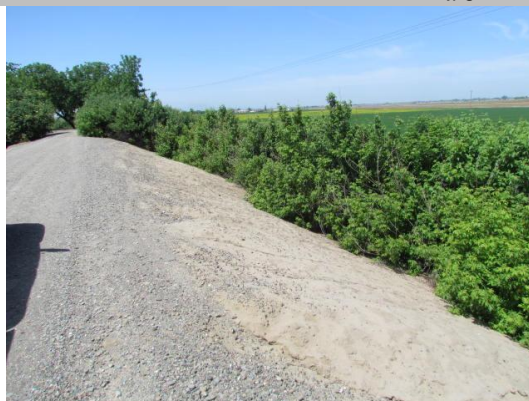
Photo 1 of 2 : richard_s_20140320_182.jpg

Looking southwest at dense vegetation on landside toe.

| Trim trees to at least five feet above ground level. | | | | | |

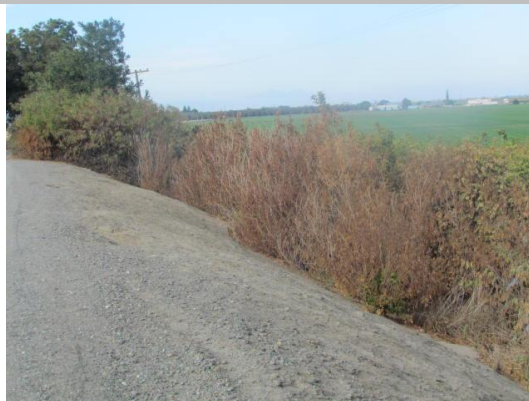
Photo 2 of 2 : richard_s_20140320_183.jpg

Looking southwest at dense vegetation and trees on landside slope.
(Fall 2012)

| Trim trees to at least five feet above ground level. | | | | | | |

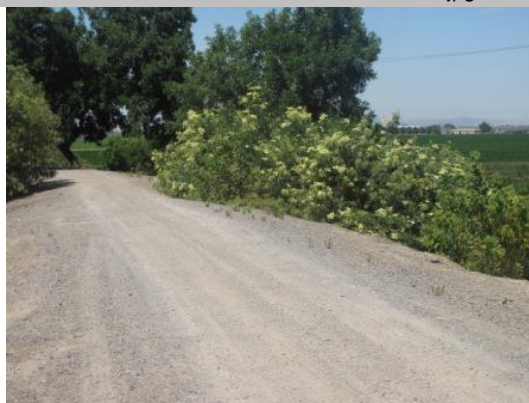
Photo 1 of 4 : richard_s_20140320_148.jpg

| Elderberries are blocking visibility and flood fight capability. | | | | | |

Looking south at elderberry on landside slope.

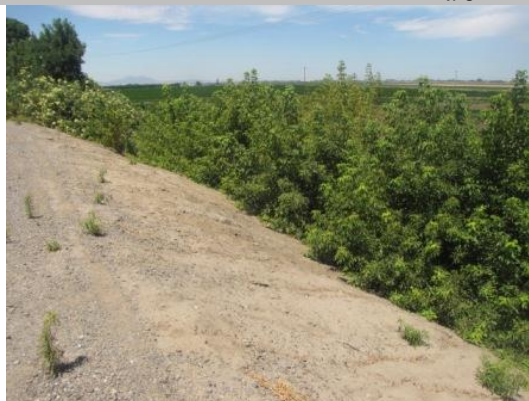
Photo 2 of 4 : richard_s_20140320_149.jpg

Looking southwest at trees along levee landside toe.

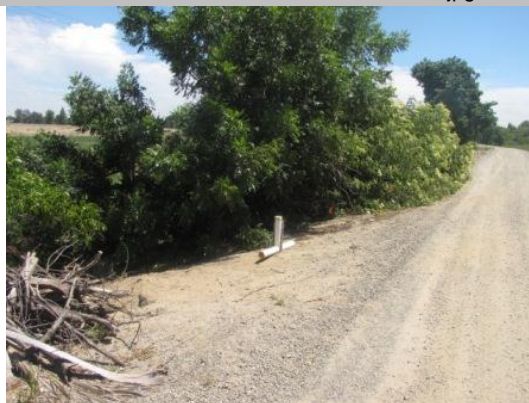
Photo 3 of 4 : richard_s_20140320_150.jpg

| Elderberries are blocking visibility and flood fight capability. | | | | | |

Looking north at elderberry and trees on landside slope.

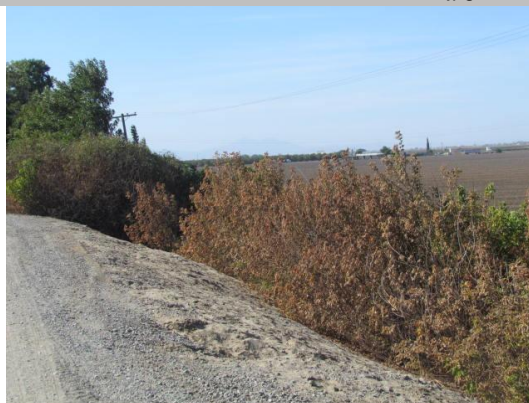
Photo 4 of 4 : richard_s_20140320_151.jpg

Looking southwest at dense vegetation on landside toe.

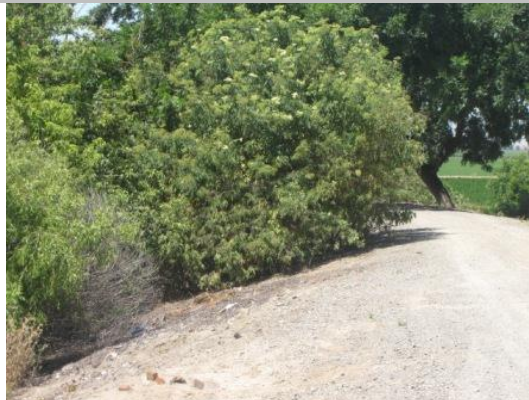
Photo 1 of 2 : richard_s_20140320_152.jpg

| Elderberries are blocking visibility and flood fight capability. | | | | | |

Looking south at elderberry on waterside slope.

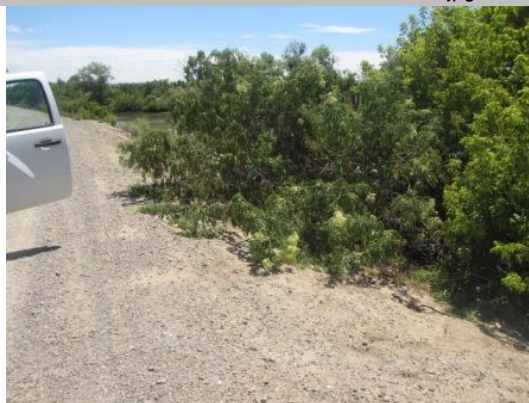
Photo 2 of 2 : richard_s_20140320_153.jpg

| Elderberries are blocking visibility and flood fight capability. | | | | | |

Looking north at elderberry on waterside slope.

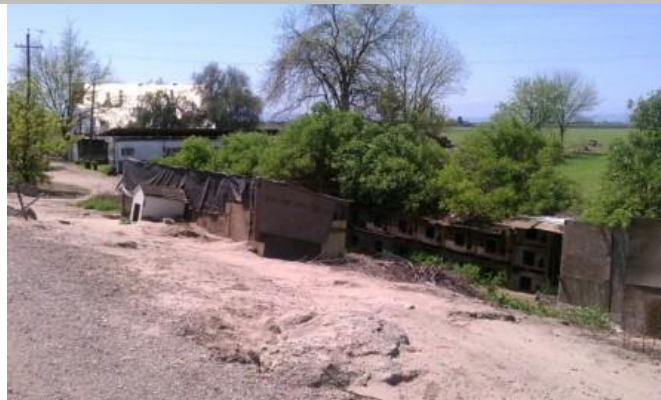
Photo 1 of 2 : richard_s_20140320_156.jpg

| Building Inspector Comments: Animal pens on landward slope and toe. | | | | | |

Looking at animal pens on landside slope and toe.

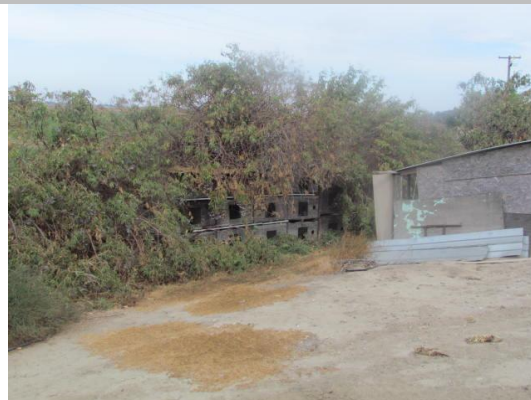
Photo 2 of 2 : richard_s_20140320_157.jpg

Looking west at animal pens on landside toe. (Fall 2012)

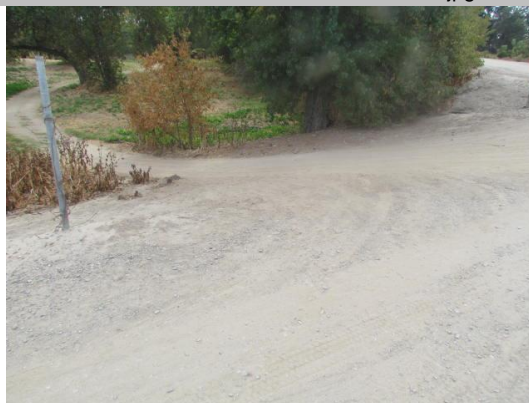
Photo 1 of 1 : richard_s_20140320_112.jpg

Looking southeast at unauthorized ramp on waterside slope.

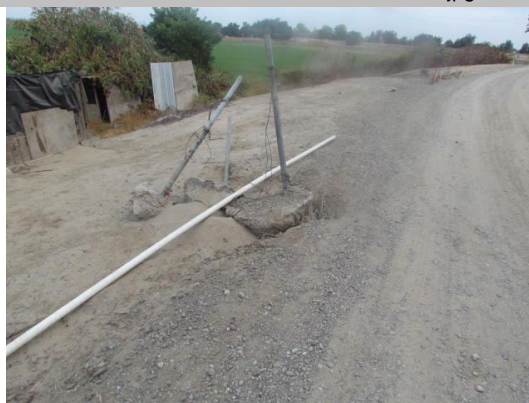
Photo 1 of 1 : richard_s_20140320_117.jpg

| Pole Inspector Comments: Old fence poles on landside shoulder and slope should be removed. | | | | | |

Looking northwest at fence poles on landside shoulder.

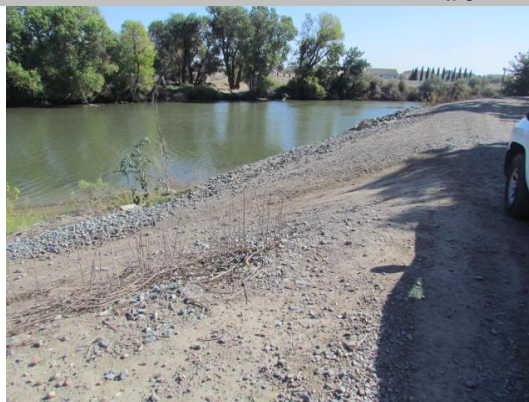
Photo 1 of 1 : richard_s_20140320_250.jpg

Looking southeast at unauthorized ramp on waterside slope.

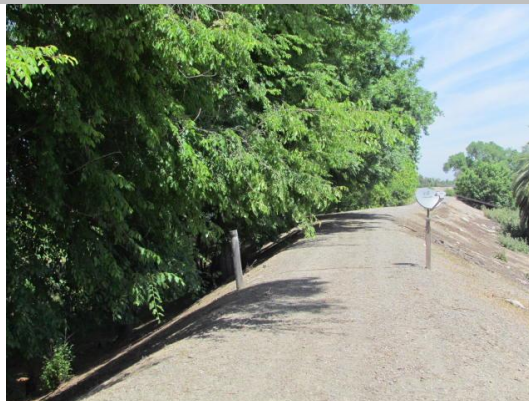
Photo 1 of 1 : richard_s_20140320_158.jpg

Looking north at dense trees overhanging levee crown.

| Trim trees over roadway to at least 12 feet above ground level. Inspector Comments: Trim over hanging trees at least 12 feet above ground level. | | | | | |

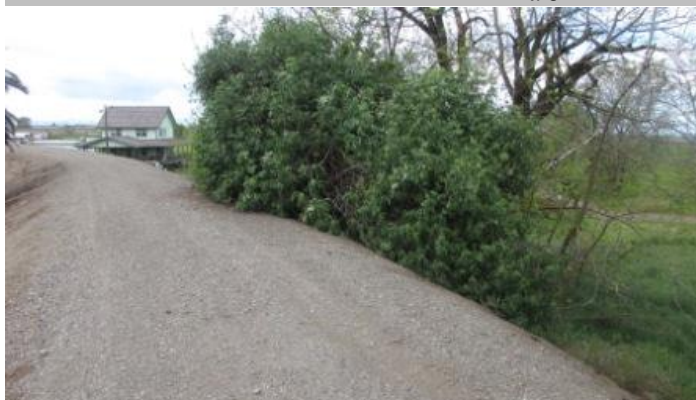
Photo 1 of 2 : richard_s_20140320_163.jpg

| Elderberries are blocking visibility and flood fight capability. | | | | | |

Looking south at elderberry on landside slope.(Spring 2011)

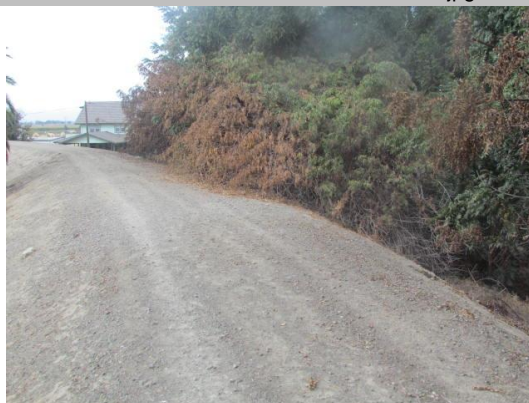
Photo 1 of 1 : richard_s_20140320_188.jpg

Looking southwest at dense vegetation on landside slope.

| Thin trees to allow visibility of the ground and room to flood fight. | | | | | |

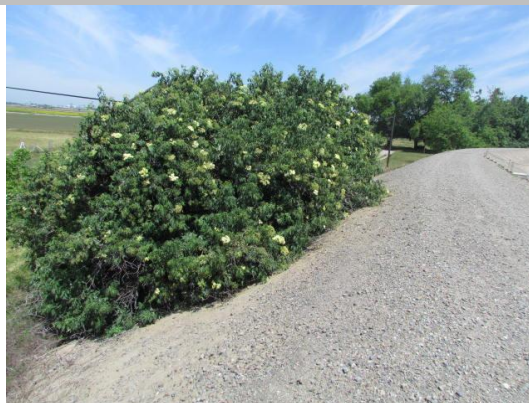
Photo 1 of 1 : richard_s_20140320_165.jpg

| Elderberries are blocking visibility and flood fight capability. | | | | | |

Looking northwest at elderberry on landside slope.

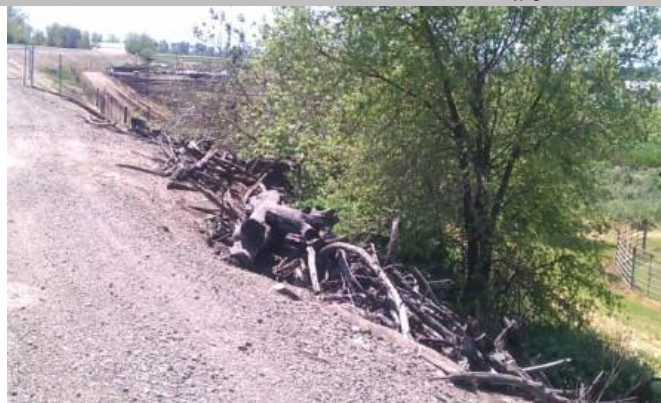
Photo 1 of 1 : richard_s_20140320_166.jpg

Looking southwest at prunings on landside slope.

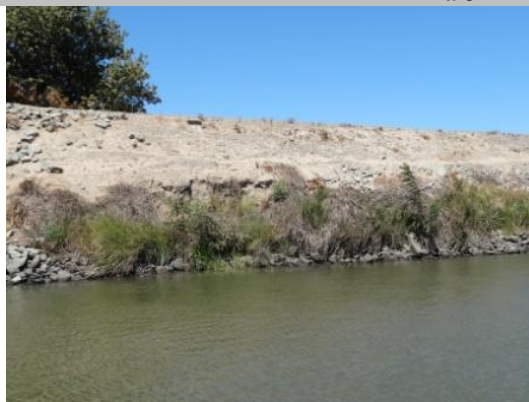
Photo 1 of 1 : richard_s_20140320_229.jpg

| Inspector Comments: 08/13/2013: The levee toe seems to have been protected by river rocks and vegetation on site. [2013 Site ID:RD0524U01RM43.86] | | | | | |

Front view of erosion.

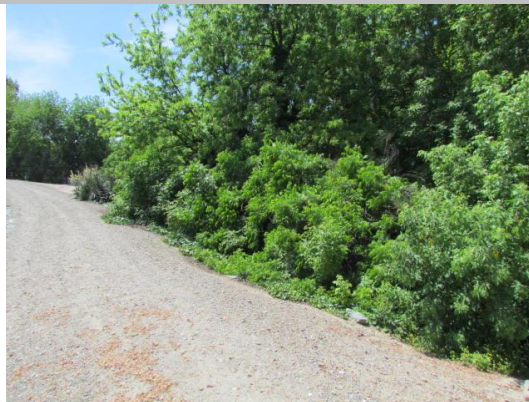
Photo 1 of 1 : richard_s_20140320_189.jpg

Looking southwest at dense landscaping on landside slope.

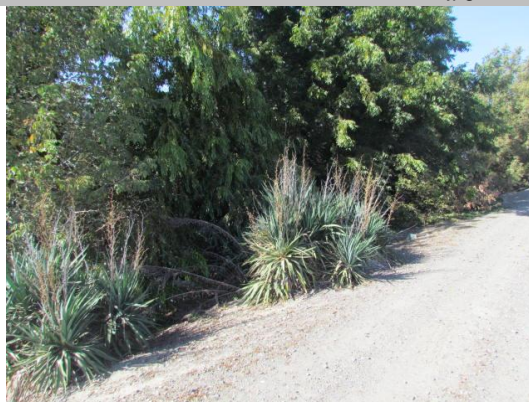
Photo 1 of 1 : richard_s_20140320_167.jpg

Looking northwest at dense vegetation on landside slope.

| Trim and thin trees to allow visibility of the ground and room to flood fight. | | | | | |

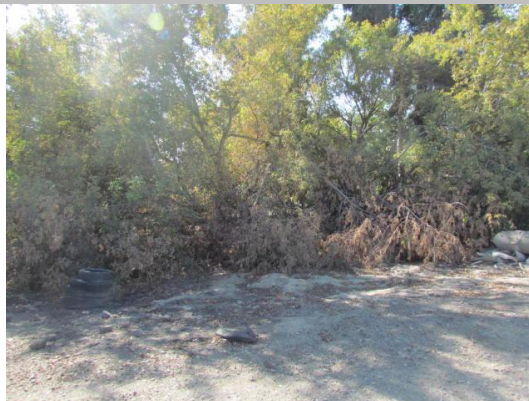
Photo 1 of 1 : richard_s_20140320_190.jpg

Looking northwest at low hanging tree branches on landside slope and toe.

| Trim and thin trees to allow visibility of the ground and room to flood fight. | | | | | |

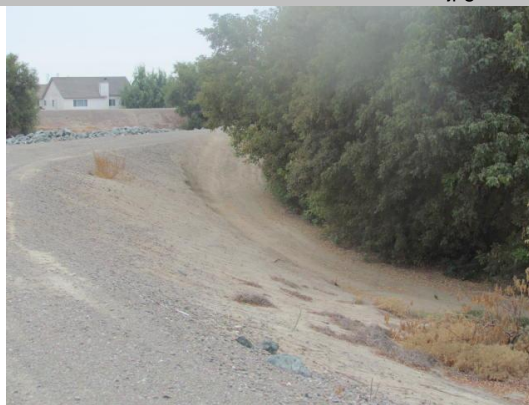
Photo 1 of 1 : richard_s_20140320_241.jpg

| Ramp Inspector Comments: Unauthorized ramp on landside slope. | | | | | |

Looking southeast at unauthorized ramp on landside slope and toe.

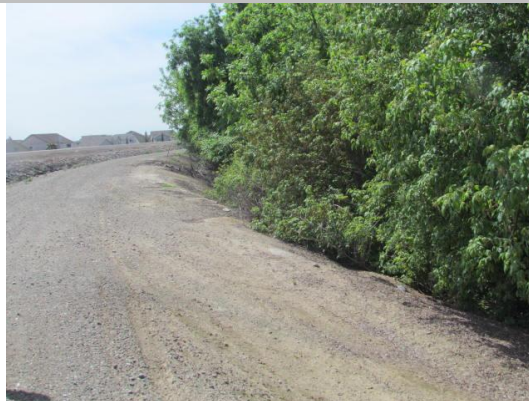
Photo 1 of 1 : richard_s_20140411_525.jpg

Looking south at dense trees on landward slope.

| Trim and thin trees to allow visibility of the ground and room to flood fight. | | | | | |

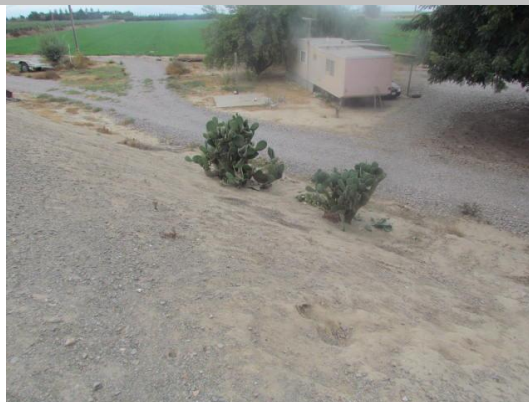
Photo 1 of 1 : richard_s_20140320_216.jpg

| Landscaping Inspector Comments: Landowner planted cactus on landside toe. | | | | | |

Looking west at cactus on landside toe.

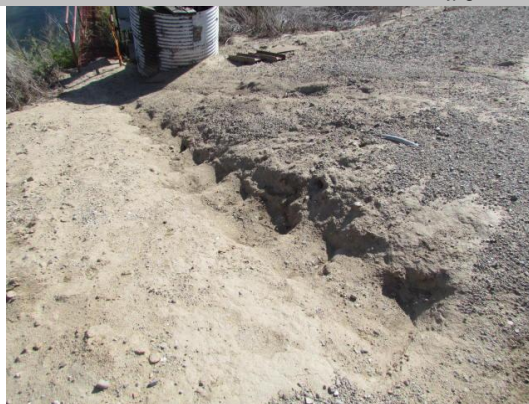
Photo 1 of 1 : richard_s_20140320_170.jpg

| Inspector Comments: Landowner cut steps into waterside slope. | | | | | |

Looking southeast steps cut into waterside slope.

| Repair the levee slope damaged by foot traffic and prevent access where possible. | | | | | |

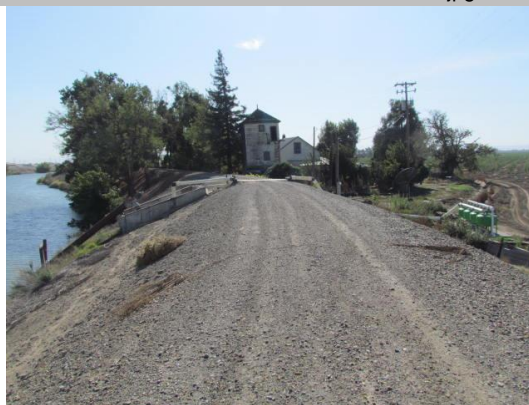
Photo 1 of 3 : richard_s_20140320_242.jpg

| Inspector Comments: Landowner installed water filter piping system without permit. | | | | | |

Looking south at unauthorized irrigation pipe across levee and water filtration system at landside toe.

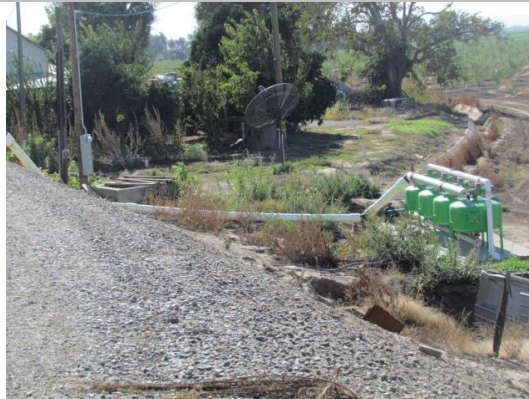
Photo 2 of 3 : richard_s_20140320_243.jpg

| Inspector Comments: Landowner installed water filter piping system without permit. | | | | | |

Looking west at water filtration system on landside toe.

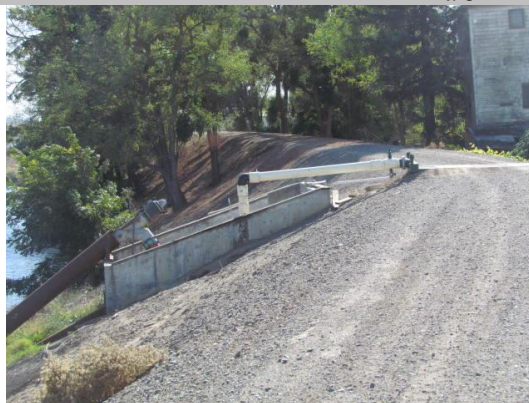
Photo 3 of 3 : richard_s_20140320_244.jpg

Looking south unauthorized pvc irrigation pipe across the levee crown.
